Technology Assessment of Liquid Encapsulants for Lead-Based Paint Abatement

Timothy D. Race and Ashok Kumar

December 2003

Final Report

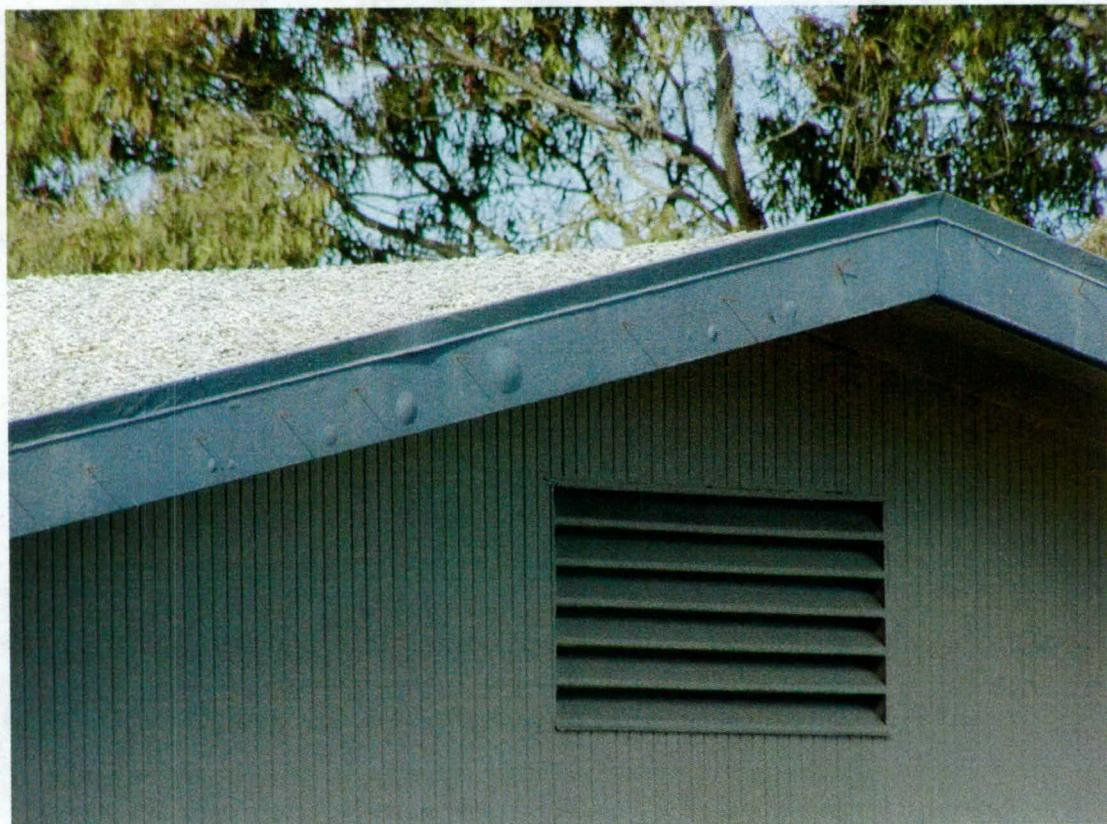
Another inherent feature of thick film elastomeric latex coatings is their relatively low water permeability compared with conventional architectural coatings. This property can be beneficial because the elastomeric coating will reduce water migration to the substrate, which in turn enhances long-term coating performance. However, this same property can also be problematic. Lower permeability also means that water can build up beneath the coating, typically resulting in premature failure of the coating. The phenomenon occurs when water enters the building envelope because of poor architectural details such as unsealed wall penetrations, unprotected roof parapets, poorly caulked windows, or lack of a vapor barrier. Once inside a wall, water will attempt to pass through the coating if the outdoor temperature is lower than the temperature of the wall. High-build elastomeric coatings pass water vapor at a lower rate than conventional thin film architectural coatings. When the driving force exceeds the ability of the coating to pass water vapor, liquid water will condense under the coating. If enough

water collects under the coating, then the paint film is displaced from the substrate and a blister is formed. Irreversible film deformation may occur as well as substrate degradation. Ultimately, the coating loses adhesion and must be repaired or replaced. The failure mechanism can also be less dramatic; as moisture retained in the wood may degrade the long-term performance of the coating to cause premature peeling.

Figure 1. Blistered encapsulant on housing unit at Fort Ord/POM.

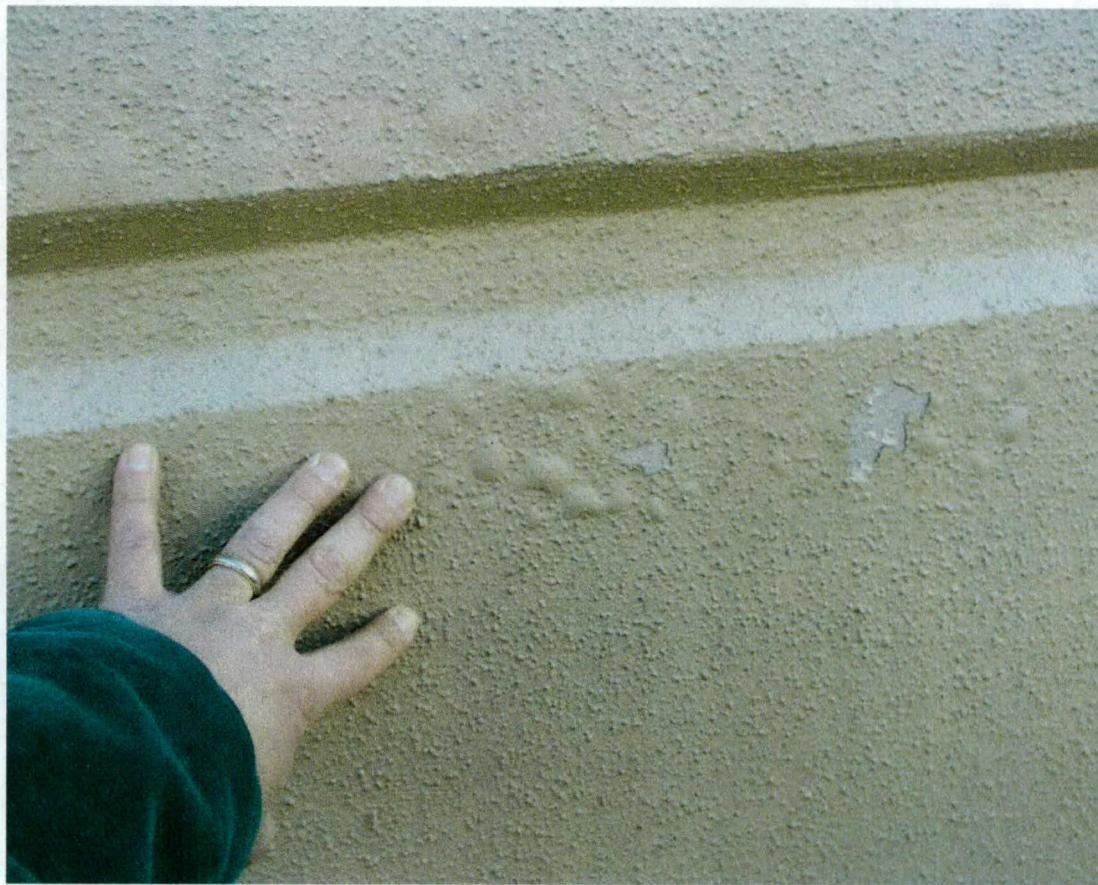
Figure 2. Blistered elastomeric latex on precast concrete warehouse structure.

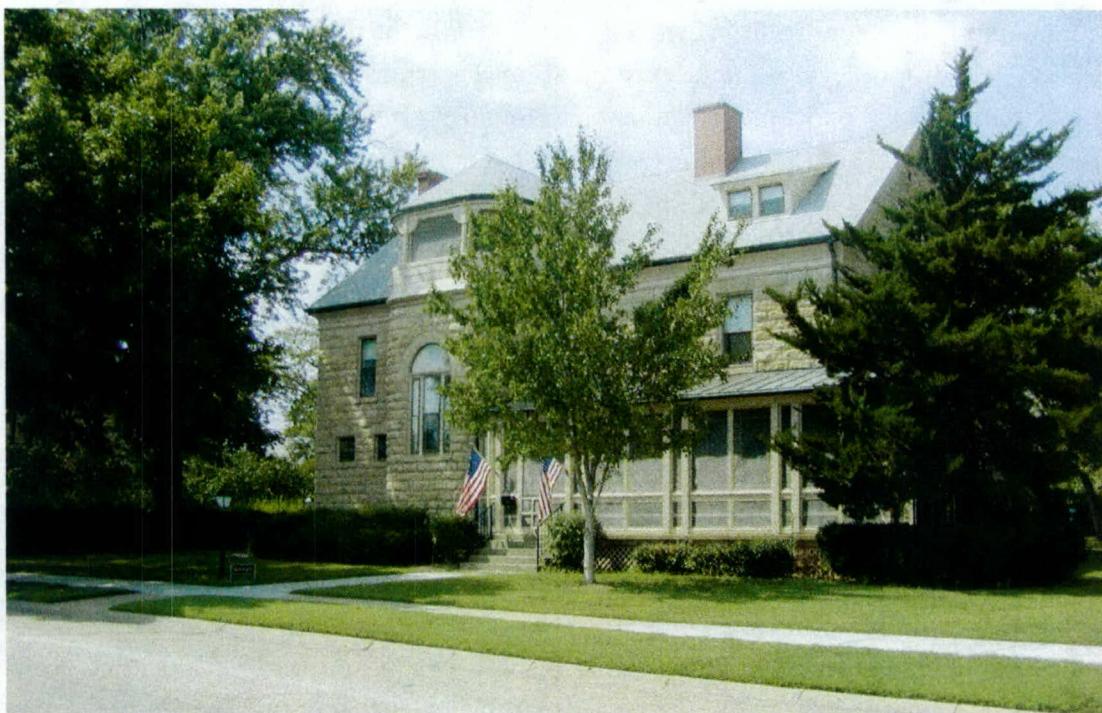
Figure 3. Aesthetically appealing example of paint stabilization at Fort Riley, KS.

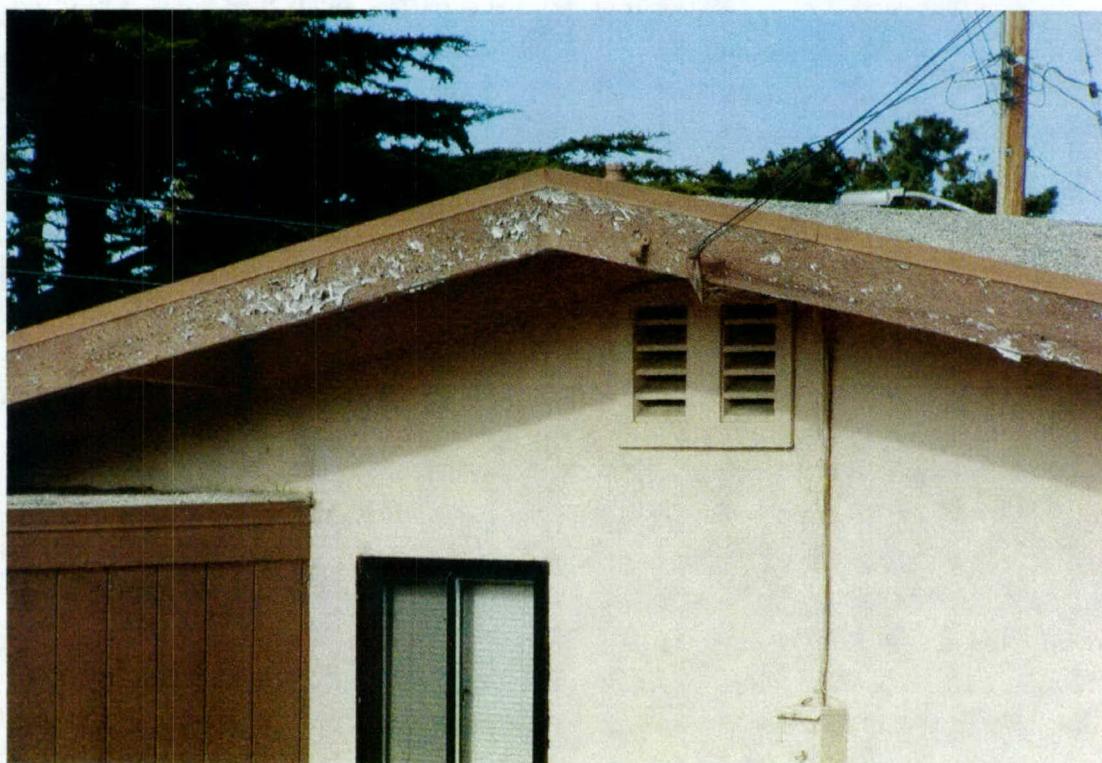
Figure 4. Poor coating condition on Fort Ord housing unit prior to encapsulation.
